Beach Protection at Meritus Pelangi Beach Resort & Spa, Pantai Cenang, Langkawi, Malaysia

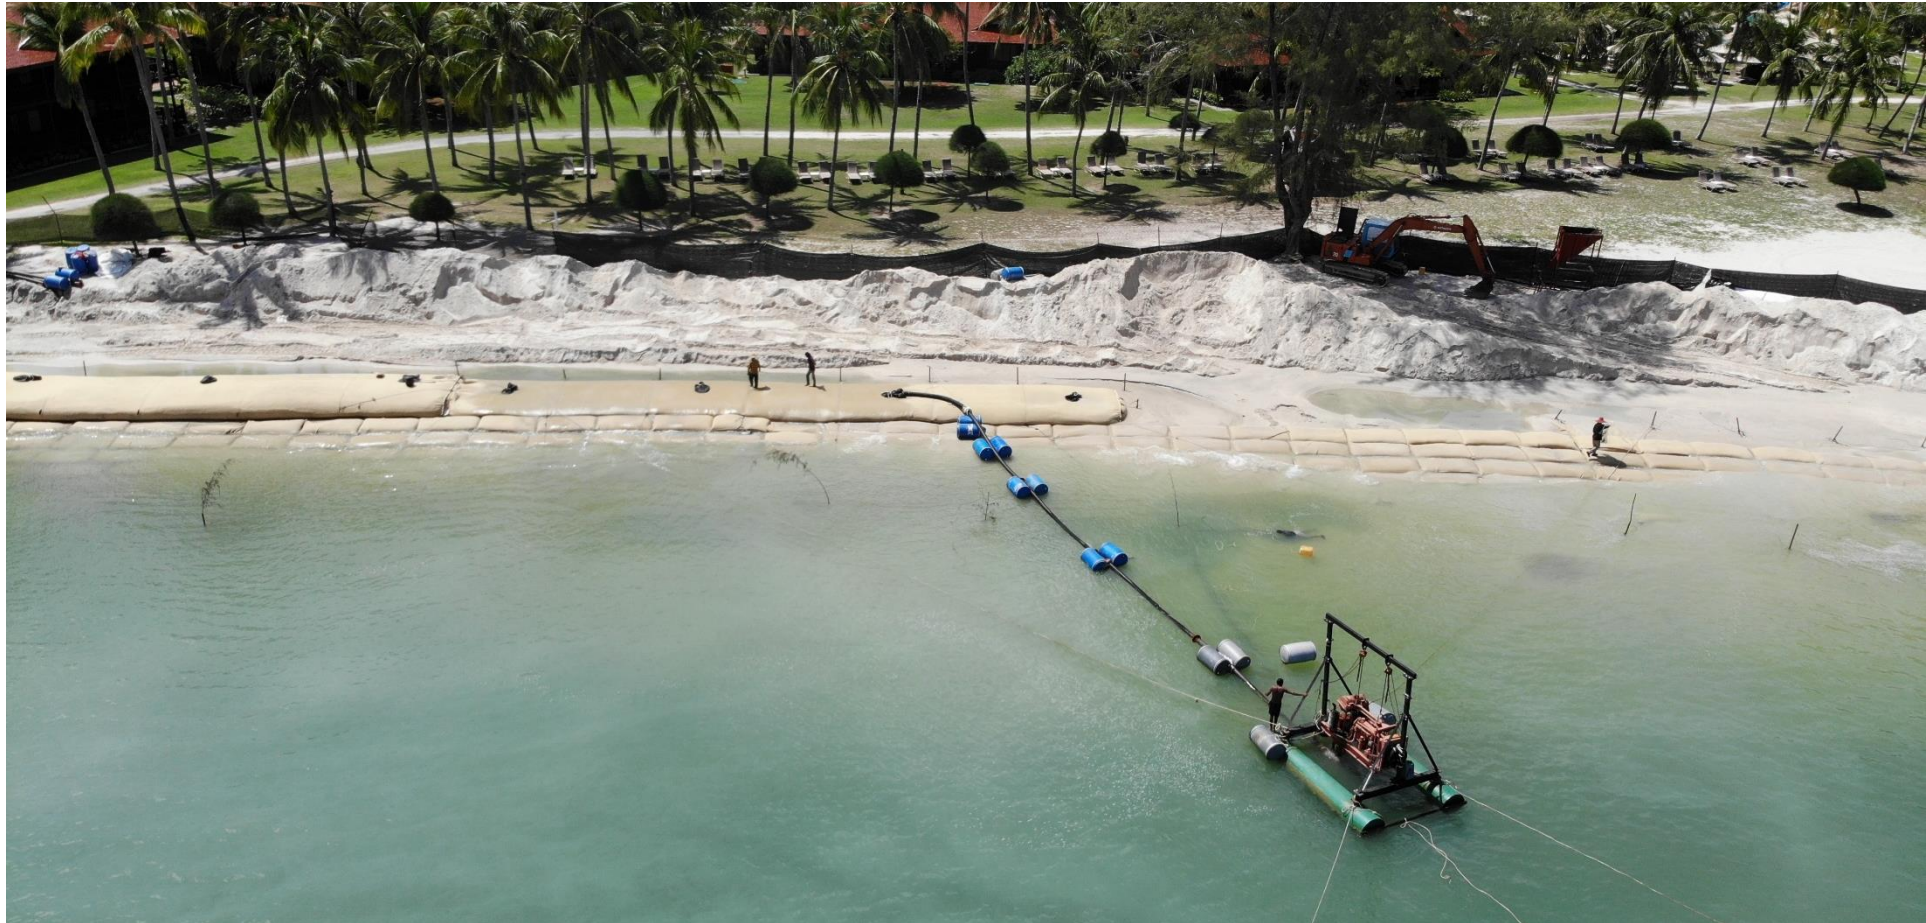
- The geotextile tube are then installed to the designated location for pumping. Timber posts are installed along the tubes alignment to guide the tubes from tilt away from the position during the initial phase of filling. A dredge pump is then used to hydraulically filled the tube with sand.

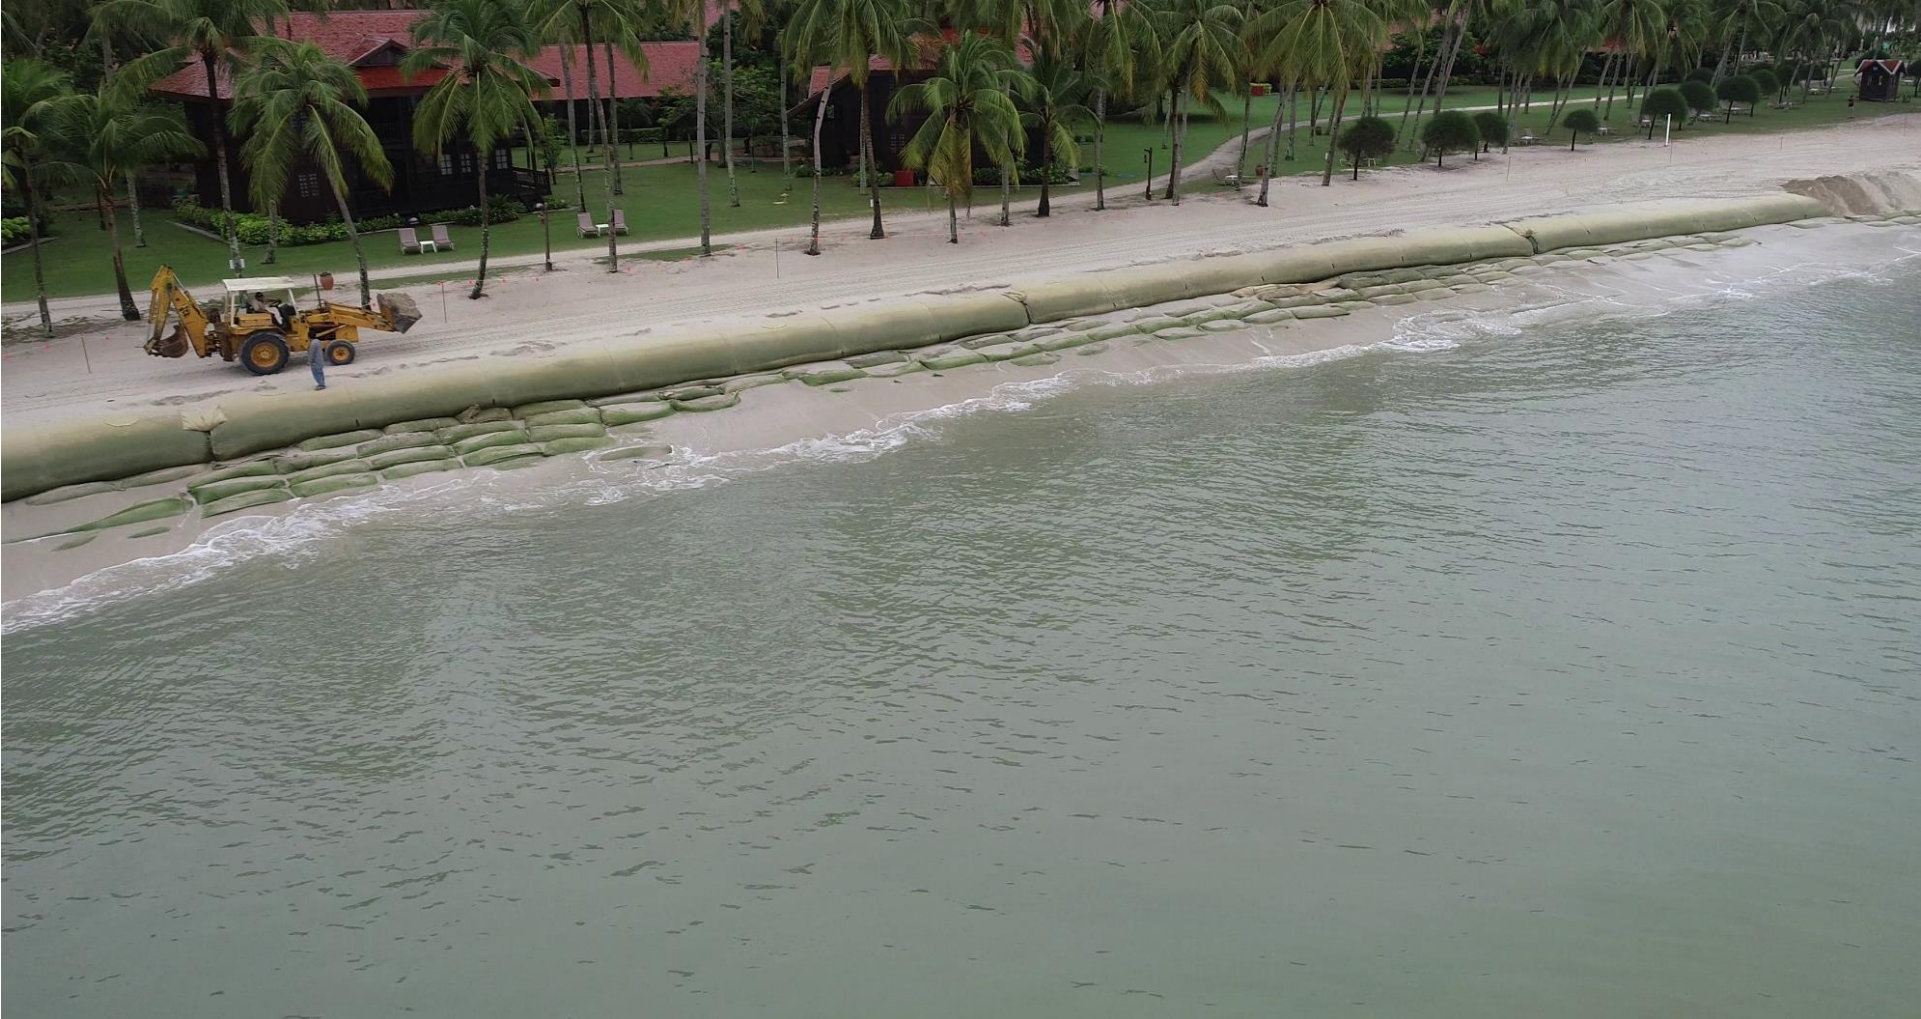
- After the installation completed, the area between the scarp and tubes are backfilled with sand to provide platform for recreational activity.
